***CACHE CREEK
TO THE
ROCKIES PROGRAM***

**Trans Canada Highway
Existing Conditions Report**

**APPENDIX 2
GEOTECHNICAL CONDITIONS**

**Ministry of Transportation
and Highways**

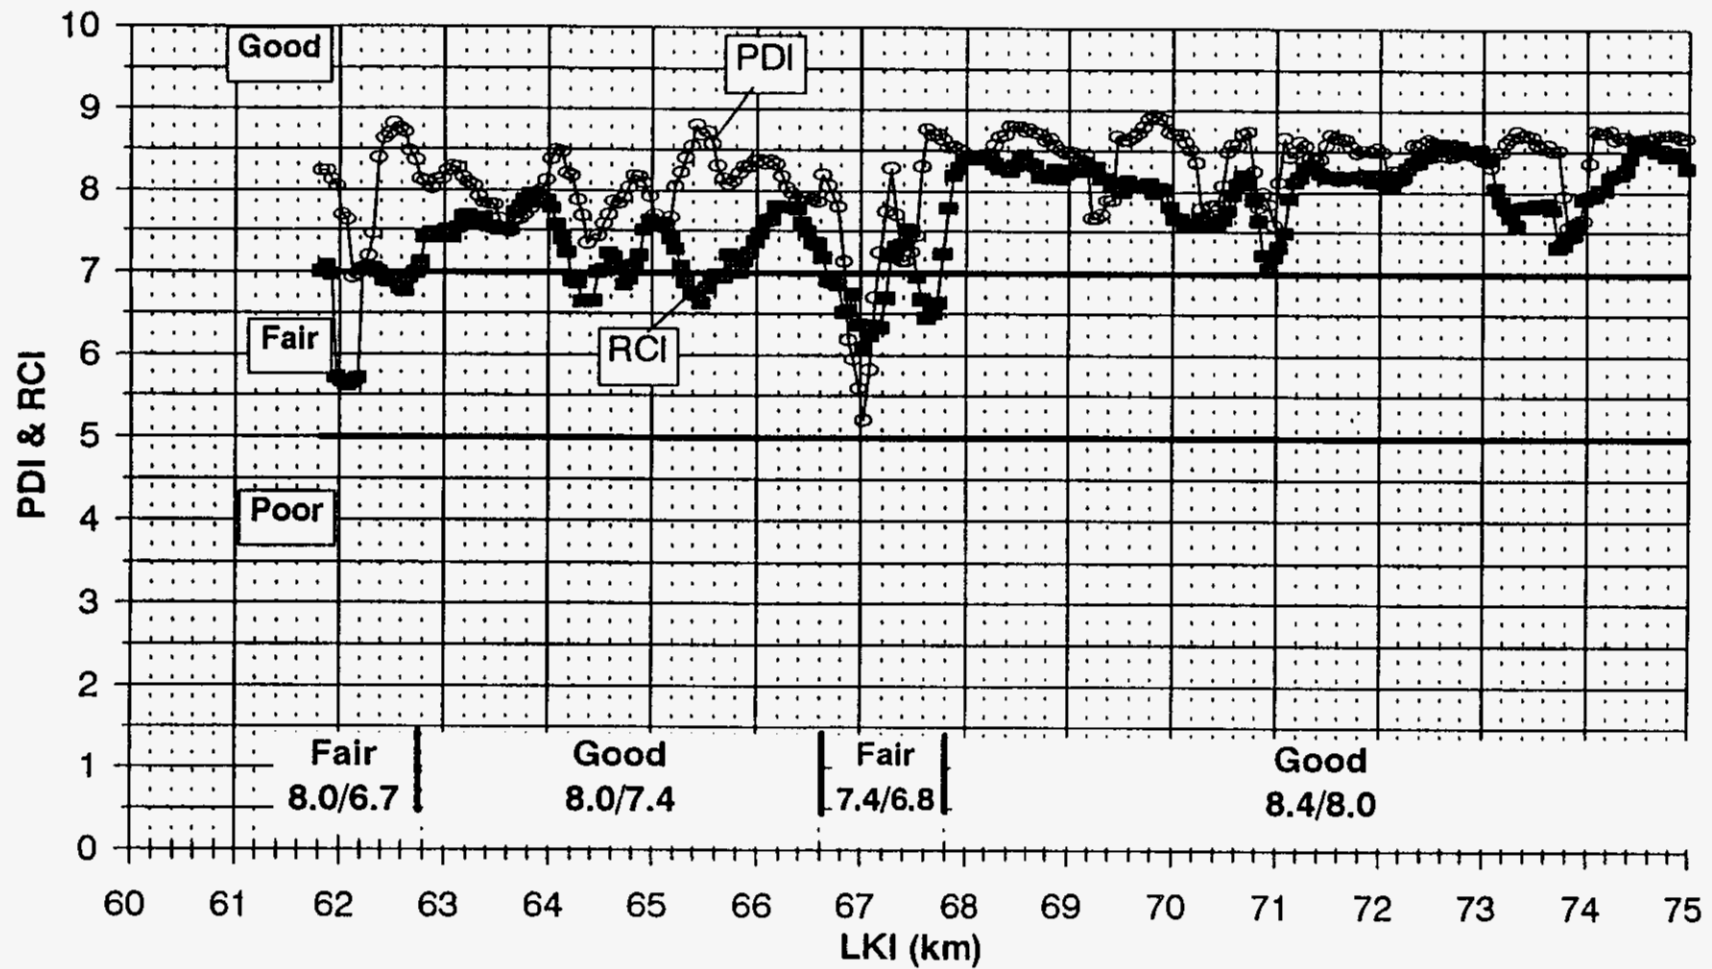
Fig. 4-1: PDI & RCI: BALMORAL - CANOE

Seg. 0935: Ford Road - Mill Entrance

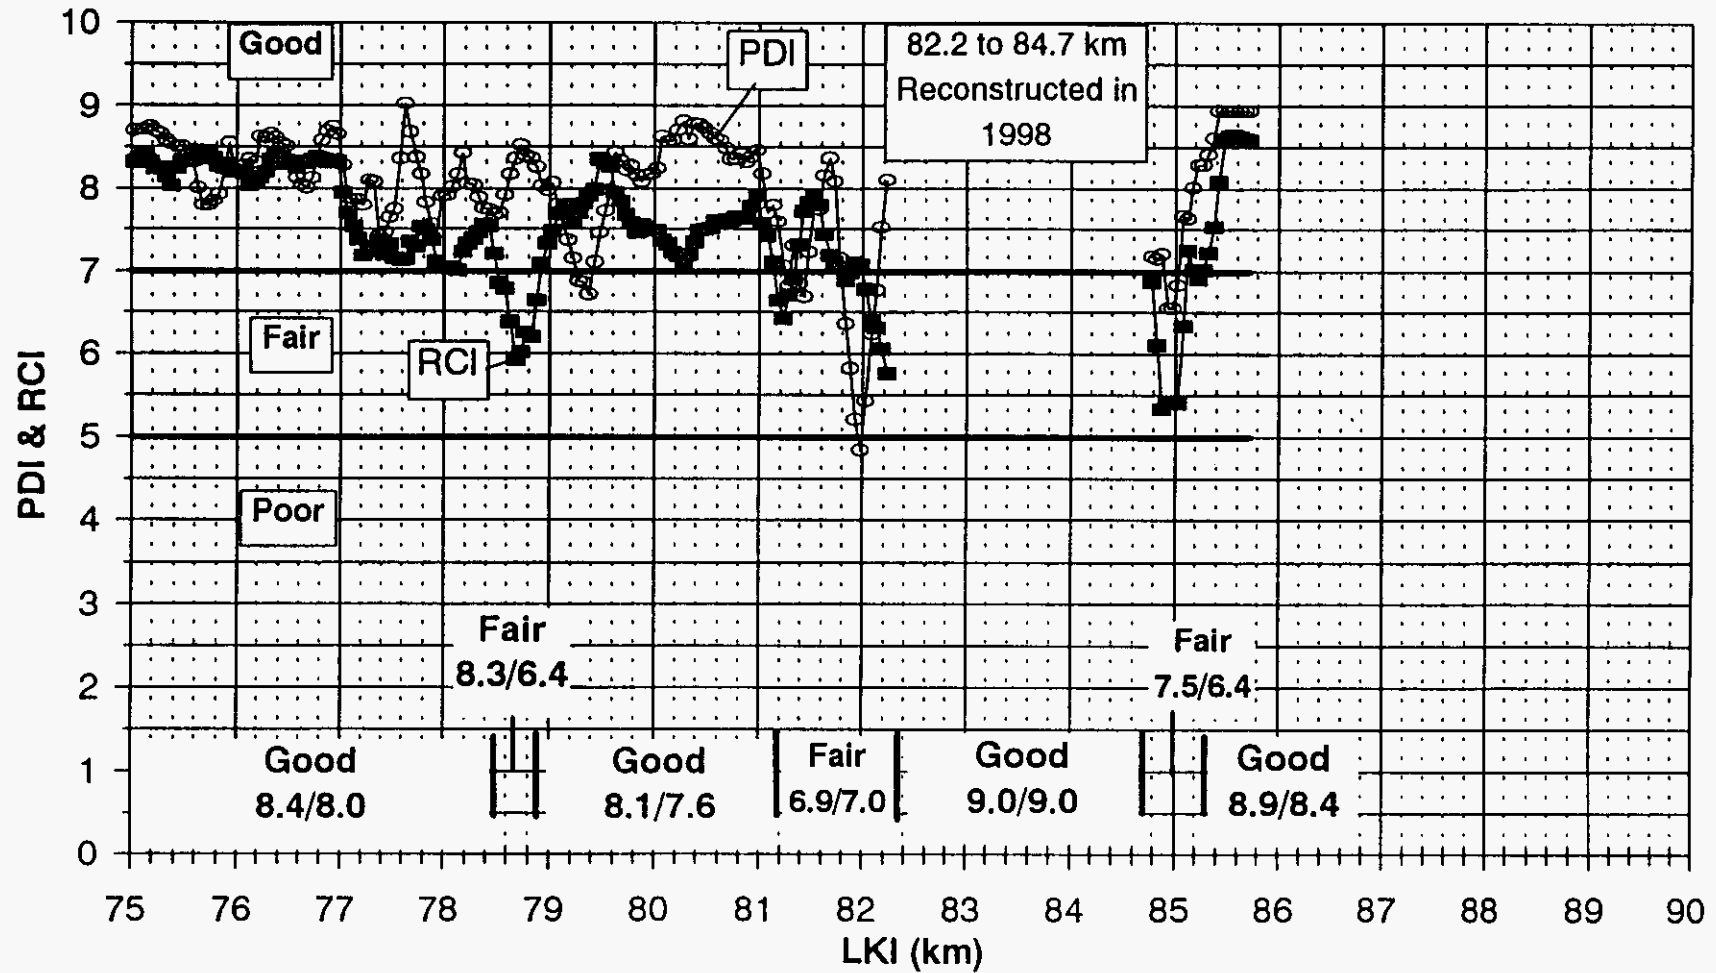
Fig. 4-2: PDI & RCI: BALMORAL - CANOE

Seg. 0935: Ford Road - Mill Entrance

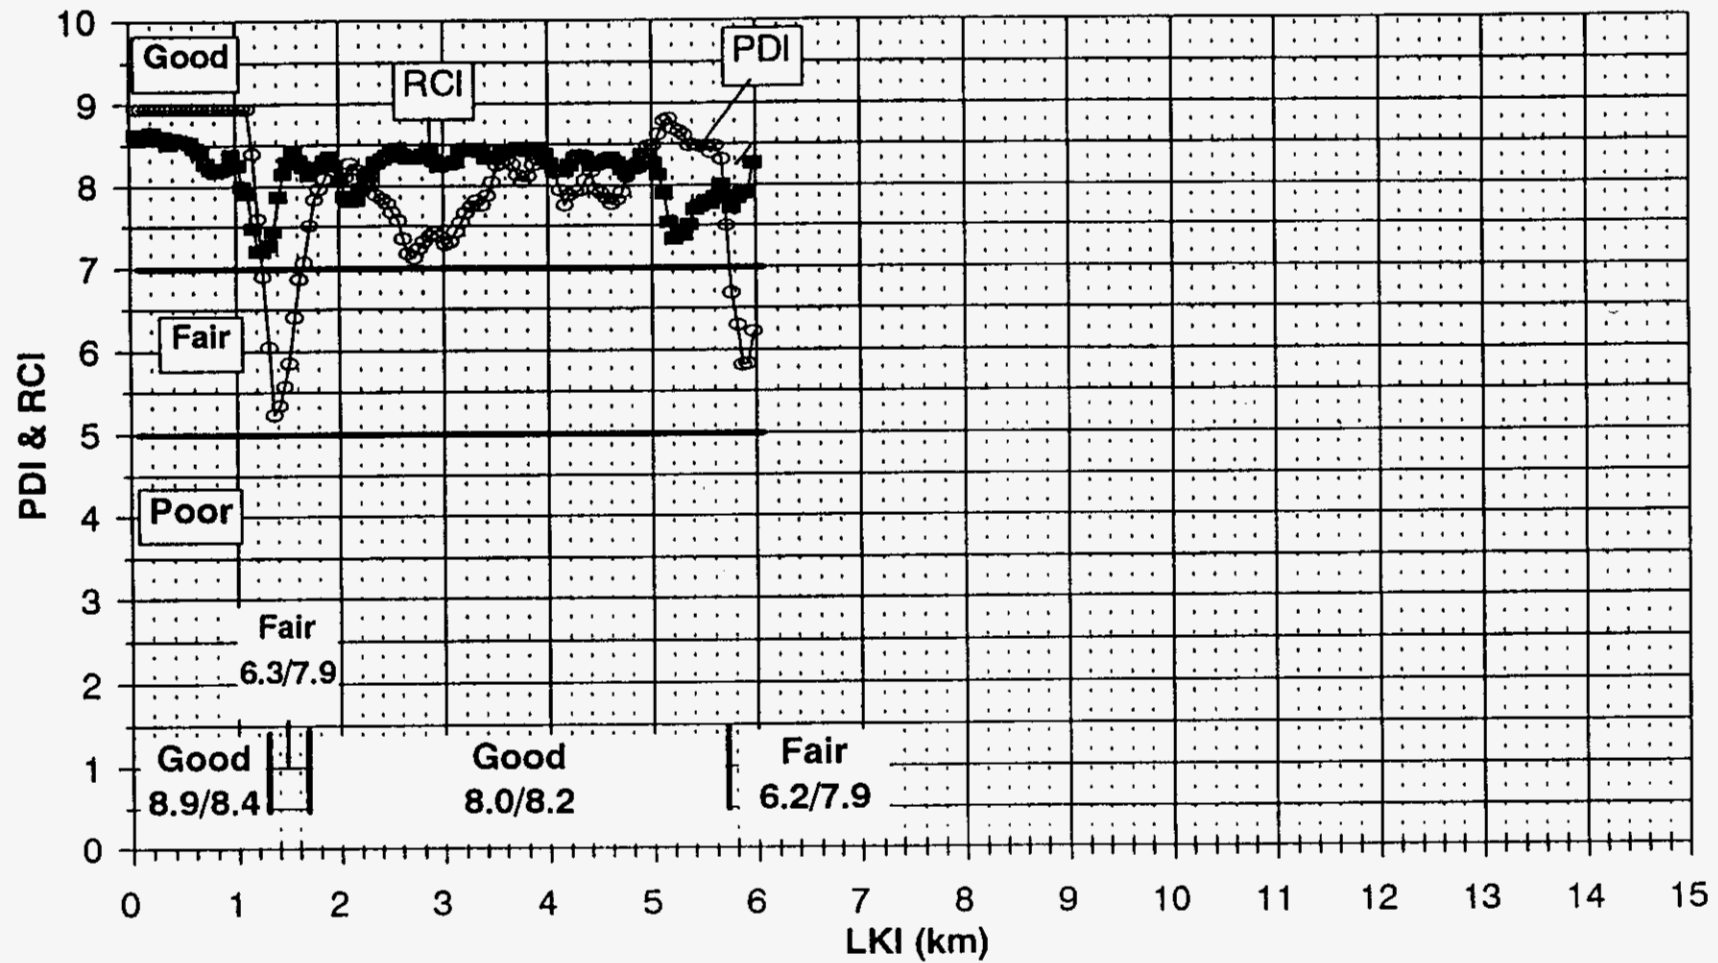
Fig. 4-3: PDI & RCI: BALMORAL - CANOE

Seg. 0950: Ford Road - Mill Entrance
